**DEPARTMENT OF TRANSPORTATION**

Contract #: 04-0120F4Cty: SF/ALA Rte: 80 PM: 13.2/13.9File #: 69.28**WELDING INSPECTION REPORT****Resident Engineer:**Siegenthaler, Peter**Address:** 333 Burma Road**City:** Oakland, CA 94607**Report No:** WIR-018532**Date Inspected:** 10-Dec-2010**Project Name:** SAS Superstructure**OSM Arrival Time:** 700**Prime Contractor:** American Bridge/Fluor Enterprises, a JV**OSM Departure Time:** 1900**Contractor:** Zhenhua Port Machinery Company, Ltd (ZPMC), Changxing Island **Location:** Shanghai, China**CWI Name:** Mr. Wang li yang**CWI Present:** Yes No**Inspected CWI report:** Yes No N/A**Rod Oven in Use:** Yes No N/A**Electrode to specification:** Yes No N/A**Weld Procedures Followed:** Yes No N/A**Qualified Welders:** Yes No N/A**Verified Joint Fit-up:** Yes No N/A**Approved Drawings:** Yes No N/A**Approved WPS:** Yes No N/A**Delayed / Cancelled:** Yes No N/A**Bridge No:** 34-0006**Component:** Orthotropic Box Girder( OBG)**Summary of Items Observed:**

## WELDING INSPECTION REPORT

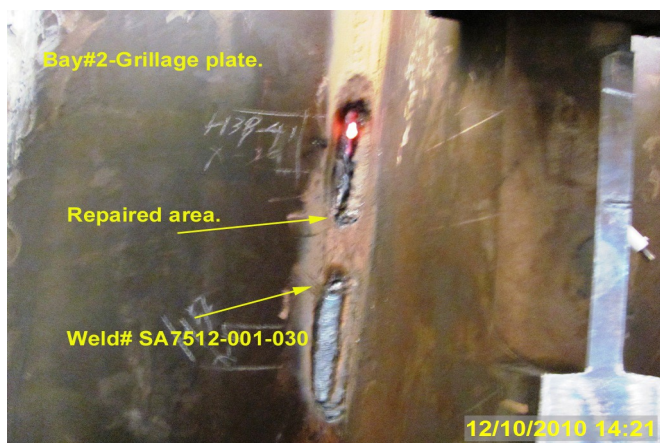
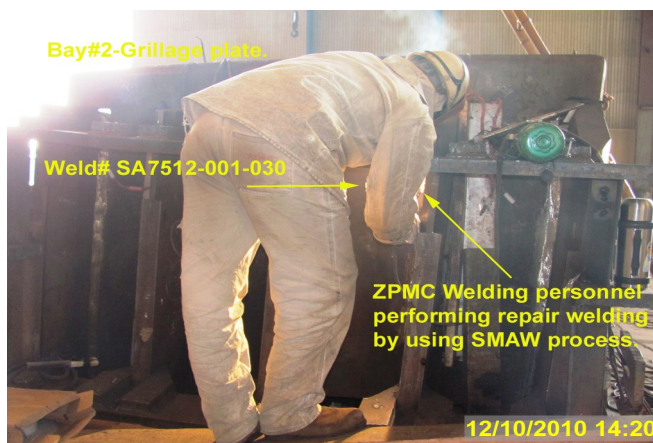
SMAW Repair welding of Grillage plate weld joint SA7512-001-030. Welder is identified as 066236. ZPMC Quality Control (QC) is identified as Mr. Li jia. The welding variables appeared to comply with the Applicable WPS: WPS-345-SMAW-3G (3F)-FCM-Repair. The repair welding was being performed as per the Caltrans Engineer approved Critical Welding Repair Report (CWR) No: B-CWR2349. This weld was rejected by ZPMC UT Technicians and recorded on UT report No: B787-UT-17609R2. Refer the attached photos for reference.
